**Ref: IAQ Field Assessment**

**Spring Hope Community Center**

**103 N May St.**

## Field Assessment Summary

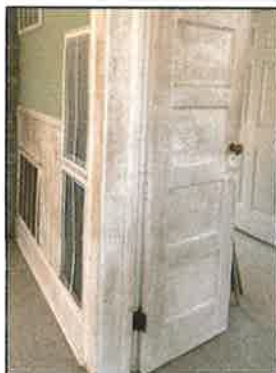
**Sample #1:**  
Door to East Wing  
(Label 760)

**Results:**  
Cladosporium-High

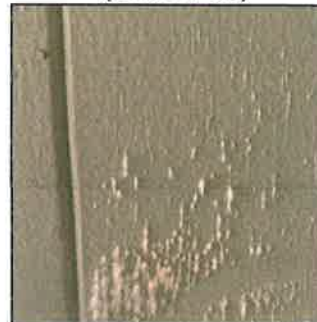
**Sample #3:**  
North Wall of Meeting  
Room on Wall panel  
above chair rail  
(Label 795)

**Results:**  
Aspergillus-High  
Penicillium/Talaromyces-High

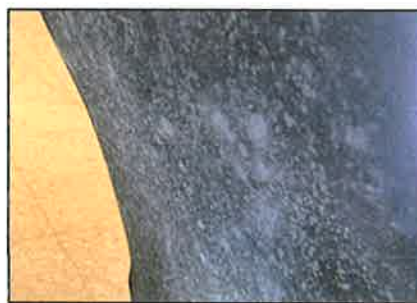
**Sample #5:**  
Back of Vinyl Chair in Meeting Room  
(Label 505)

**Results:**  
Cladosporium-Medium  
Aspergillus-High

3. Remove window blinds, items in cabinets, all loose furniture and elements not fixed to structure, cleaning and storage until building is safe for their replacement. Dispose of contaminated vinyl chairs and other such items that cannot be easily cleaned or replaced.

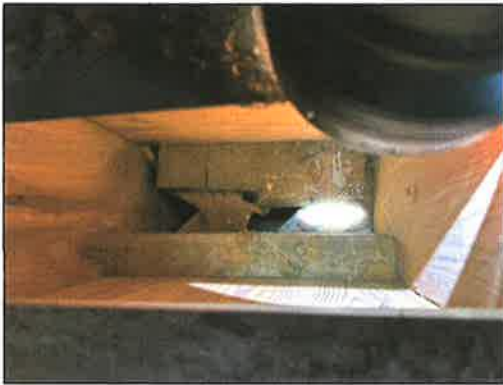
- d. **West End Wall Air Return:** The air returns observed freely communicate with both the wall cavity and crawl space (photos below). Air returns are under a negative pressure when the HVAC is operating; drawing unconditioned air (and humidity) into the ductwork from both the adjacent wall cavity and crawl space. As framed, the wall cavity freely communicates with both the attic and crawl space.

Wall gap in front of Air Return plenum:  
Note floor sheathing (top of photo)  
projecting into wall cavity (center of photo)

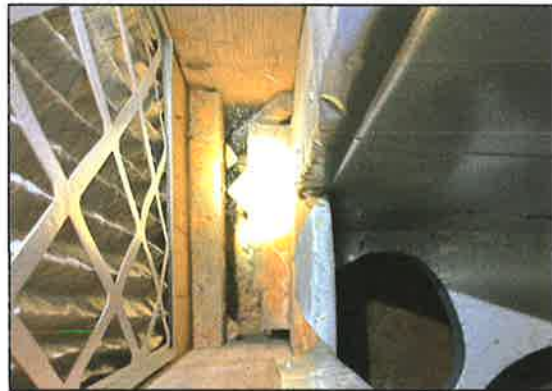
Note wall cavity between air filter and metal return plenum. Wall cavity communicates with crawl space

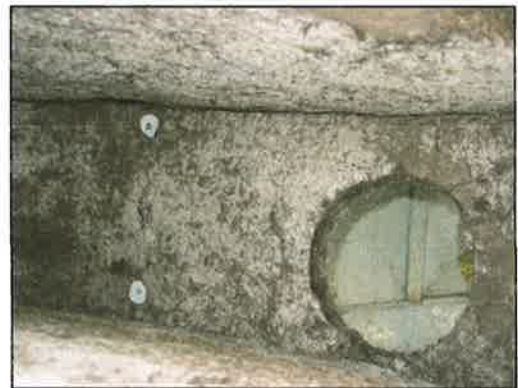
- e. **Lined Metal Ducts:** Interior lined metal ducts (i.e., duct liner) were observed and the observable portions have a significant dust buildup on the interior surface of the duct liner. Such buildup can commonly lead to the development of mold on the duct liner (example photo at right). Lined metal ducts cannot be safely cleaned/disinfected and should always be replaced.

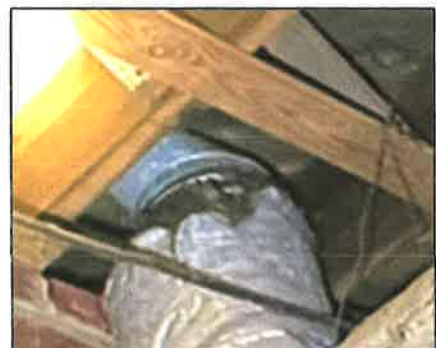
- f. **Supply Duct Floor Boots:** Floor boots have not been thermally sealed off at floor penetration and duct insulation stops short of (with an open end) of the floor. See photo below.
- g. **Supply floor registers, interior of metal ducts:** We removed some corroded metal floor registers and found various degrees of corrosion from light rust discoloration to extensive flaking rusted metal. This condition is indicative of elevated moisture in ducts.

Similarly, corroded metal wall outlet and switch plates, metal return grills, was also apparent.

2. Seal all boot to floor and duct to boots, ensuring insulation vapor barriers are terminated to meet code.
3. Employ a NC Licensed Mechanical Engineer to design a new HVAC system; system to be installed by a Licensed HVAC Contractor.
4. Check any and all exhaust fans for compliance and presence of a backflow damper. If not damper, replace. Seal accordingly.
5. In toilets, we suggest placing the fan on a timer (presets ranging from 1 to a maximum of 30 minutes operation) to ensure the fan does not operate continuously when building is unoccupied.
6. Perform a pressure test on duct system.
7. Mechanical Contractor should be requested to obtain a mold compliance air test upon completion of HVAC installation (as a benchmark).

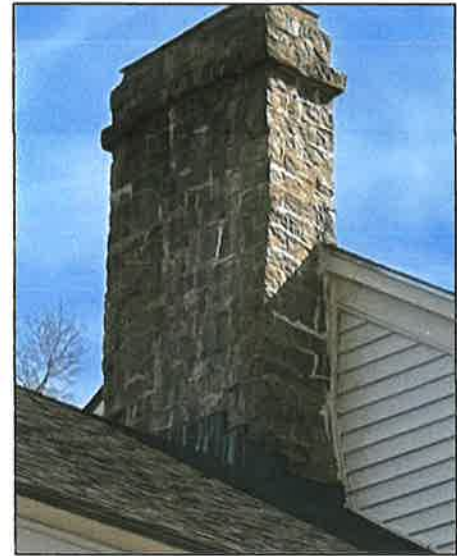
- a. Though it appears that the persistent roof leak issue may have been addressed for the time being, the construction of this chimney and the conduit it offers along its perimeter in contributing to permitting unconditioned air in and conditioned air out, can be significant.

- b. Due to the past issues with leakage at the roof plane and though the firebox has been blocked up, we recommend removal of the upper chimney down to below the roof rafters and then capping the stack (on top of the remaining chimney). Alternatively, the chimney could be removed in its entirety to below the floor framing.

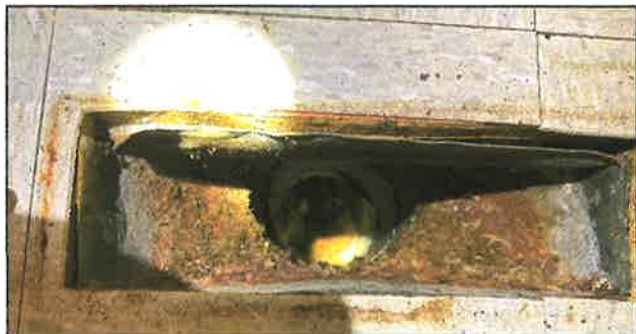
Flaking corrosion extends down boot into metal duct elbow...note corrosion at bottom duct elbow

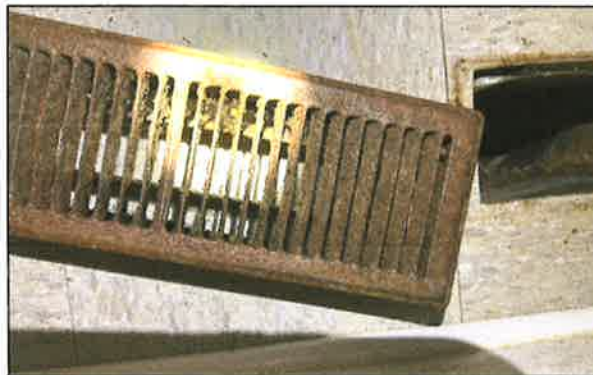
Typical surface corrosion on metal floor registers

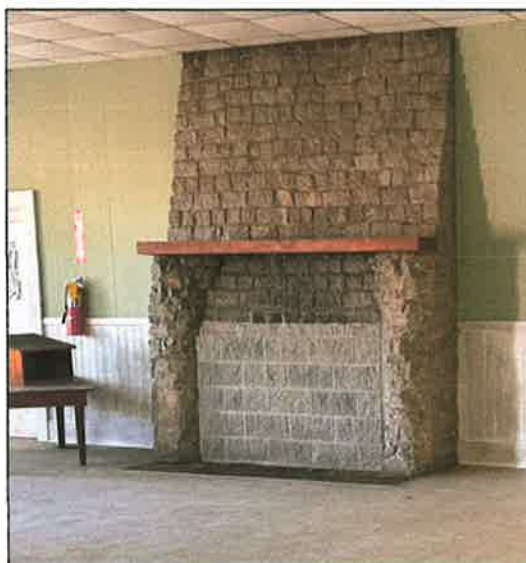
Both Chimney Fireboxes blocked up  
Note mold on wainscoting both sides of Chimney

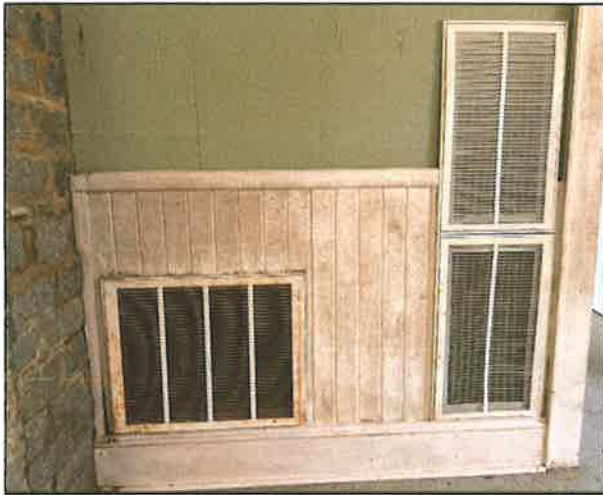
Corroded return grill, extensive mold development around air returns; mold spores pulled into air handling unit and conveyed throughout entire building

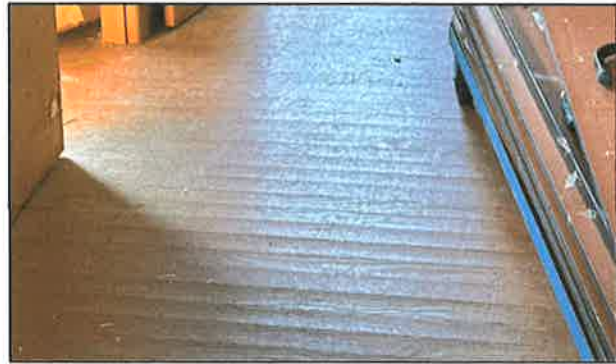
Cupped hardwood flooring on east wing

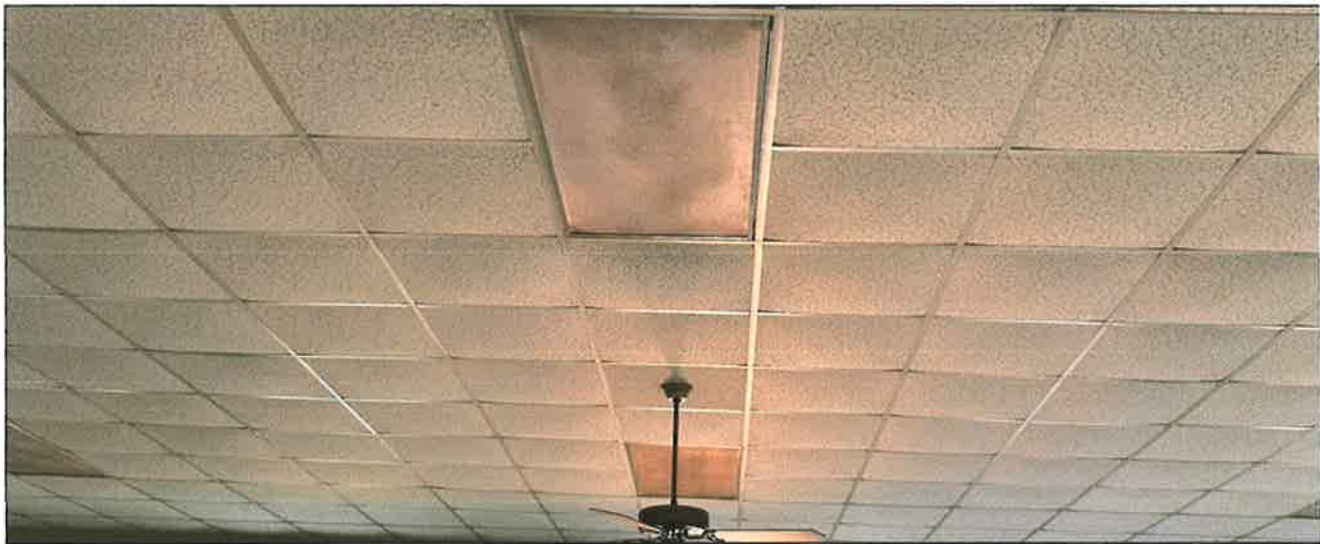
In meeting hall, cupped 2'x2' ceiling tile (with fiberglass insulation batts on top). Condition is; frequently indicative of elevated humidity in building

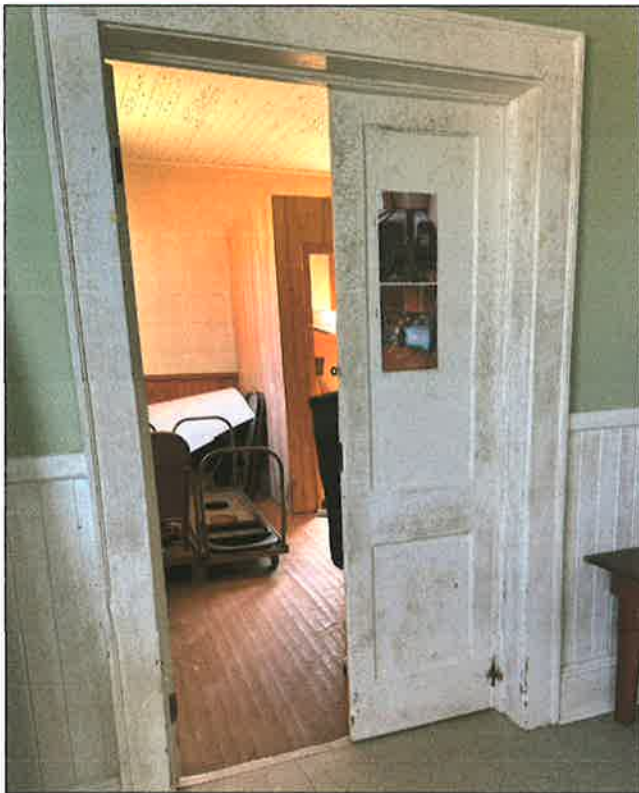
An example of the pervasiveness of mold in this building (below). Wall outlet plate corrosion is apparent source of air infiltration

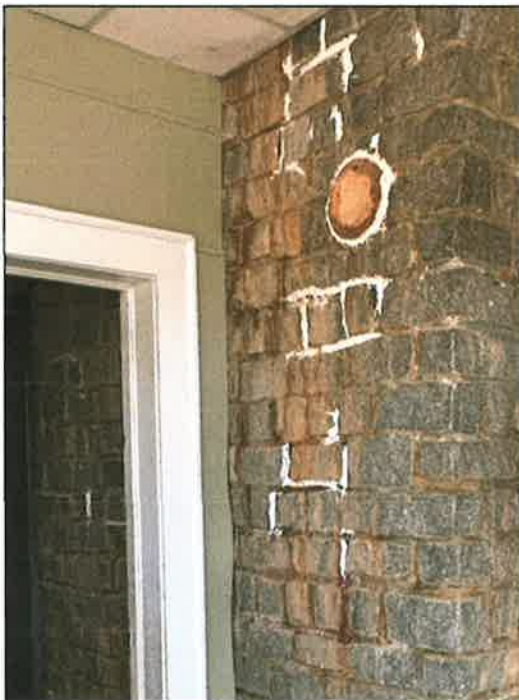
Apparent attempts to mitigate leaks around chimney

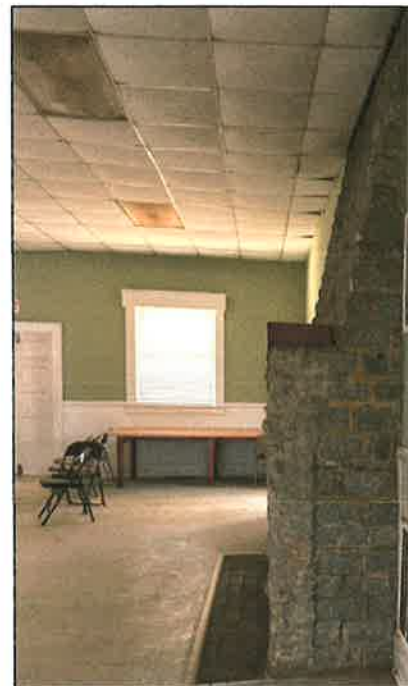
Cupped ceiling tile, above , stained light fixtures, staining on chimney surface from roof leaks
